ASBESTOS MATERIALS SURVEY Refurbishment / Demolition Survey

34B Abbey Road
London

Date of Issue: 07/06/12

Project Ref: AEC1206/07/1

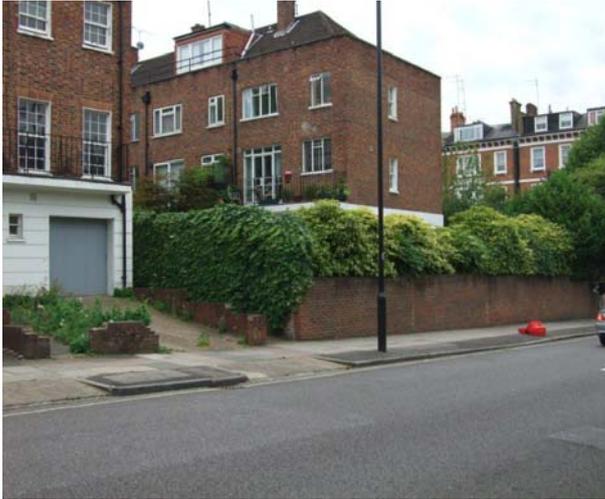
Photo ref: 1
Floor: External rear
Room:
Position:
Product: No visible suspects

Material Assessment: N/A
Risk Category:

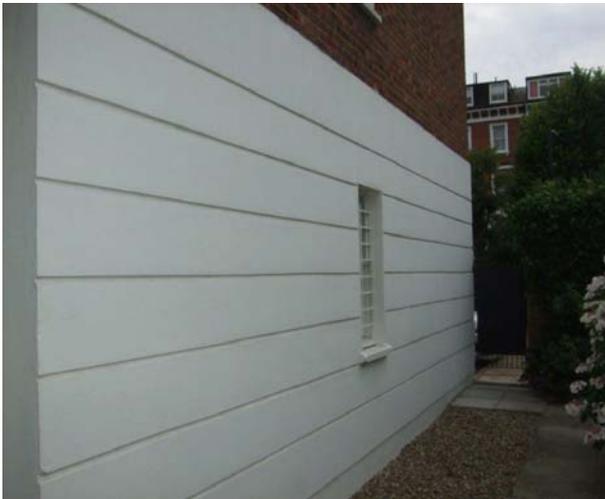
Photo ref: 2
Floor: View of rendered wall rear garden
Room:
Position:
Product: No visible suspects
Material Assessment: N/A
Risk Category:

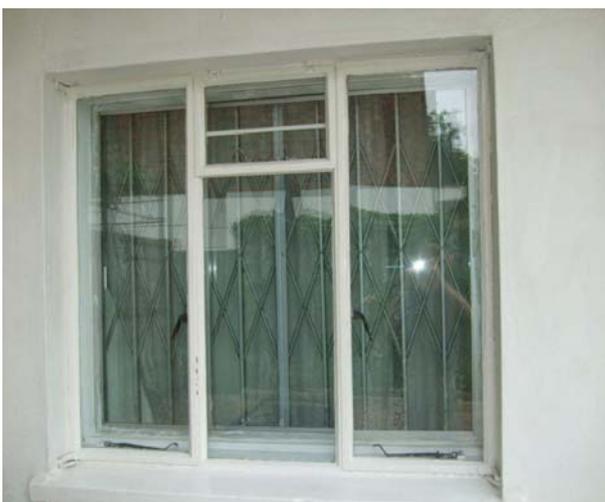
Photo ref: 3
Floor: rear window
Room:
Position:
Product: No visible suspects

Material Assessment: N/A
Risk Category:

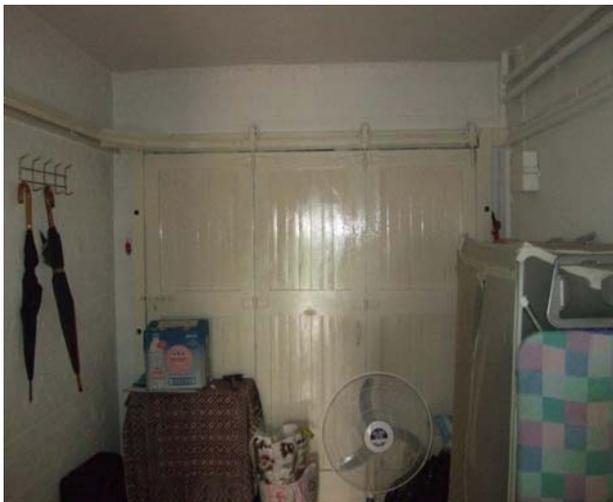
Photo ref: 5
Floor: ground
Room: Garage
Position:
Product: No visible suspects

Material Assessment: N/A
Risk Category:

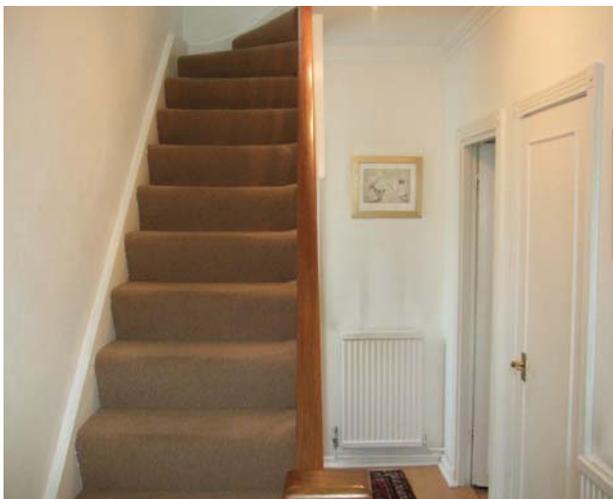
Register ref:
Photo ref: 6
Floor: Stairs / entrance
Room:
Position:
Product: No visible suspects

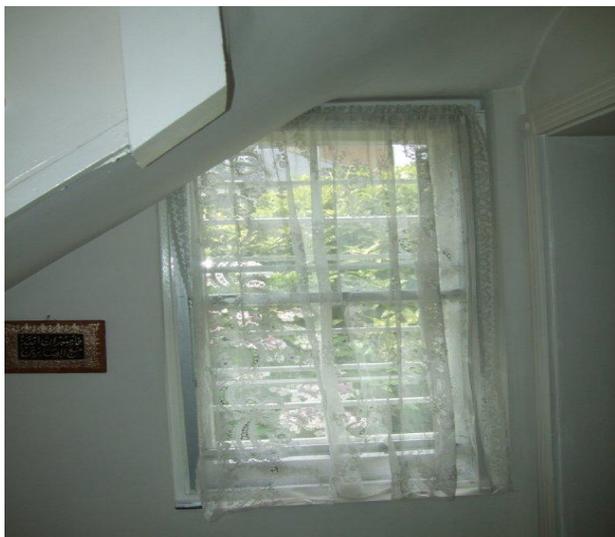
Photo ref: 7
Floor: Ground
Room:
Position:
Product: No visible suspects

Material Assessment: N/A
Risk Category:

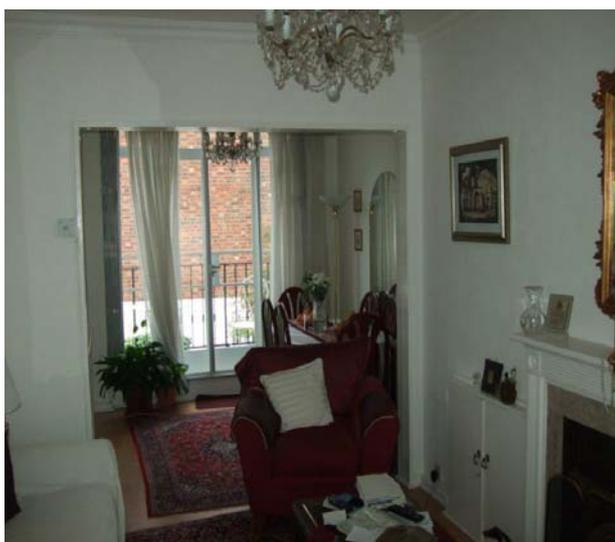
Photo ref: 8
Floor: 1st
Room: Living room
Position:
Product: No visible suspects

Material Assessment: N/A
Risk Category:

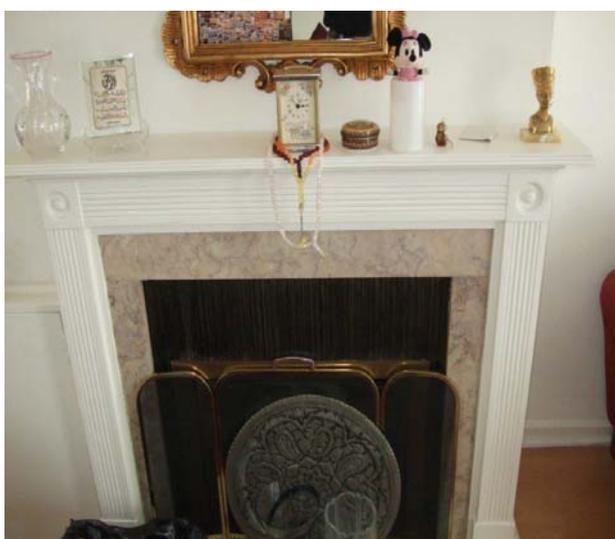
Photo ref: 9
Floor: 1st
Room: living room
Position: fireplace
Product: No visible suspects

Material Assessment: N/A
Risk Category:

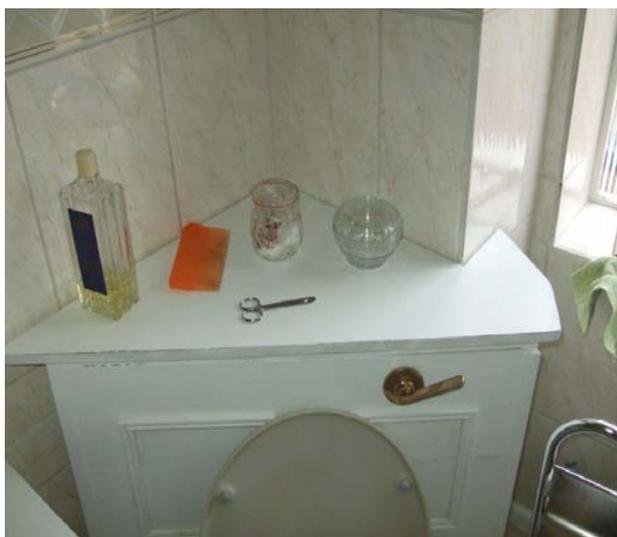
Photo ref: 10
Floor: 2nd
Room: Bathroom
Position:
Product: No visible suspects

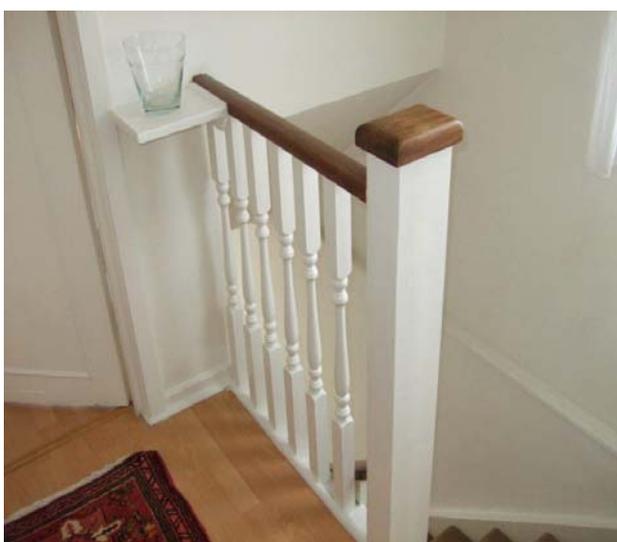
Photo ref: 11
Floor: 2nd
Room: Balustrade
Position:
Product: No visible suspects

Material Assessment: N/A
Risk Category:

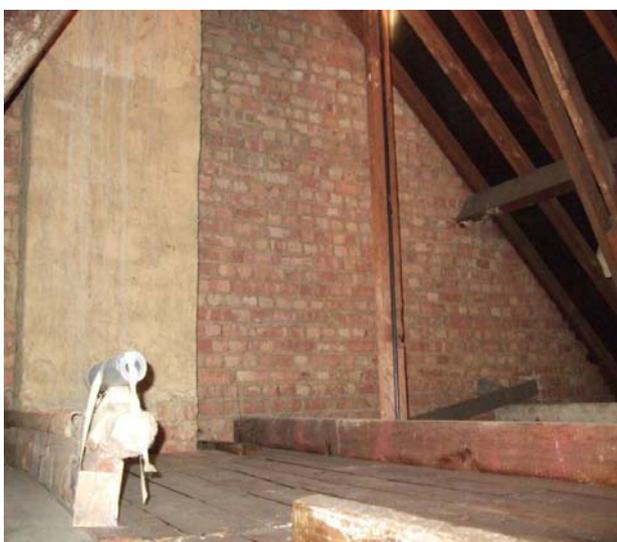
Photo ref: 12
Floor: loft
Room:
Position: Party wall and roof
Product: No visible suspects

Material Assessment: N/A
Risk Category:

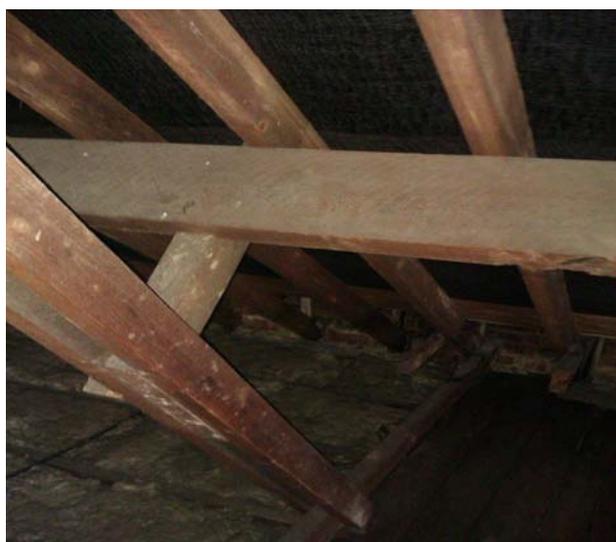
Photo ref: 13
Floor: roof structure
Room:
Position:
Product: No visible suspects

Material Assessment: N/A
Risk Category:

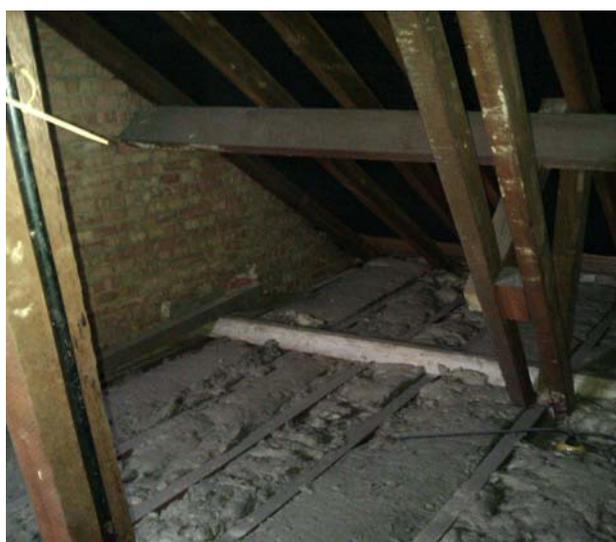
Photo ref: 14
Floor: roof structure
Room:
Position:
Product: No visible suspects

Material Assessment: N/A
Risk Category:

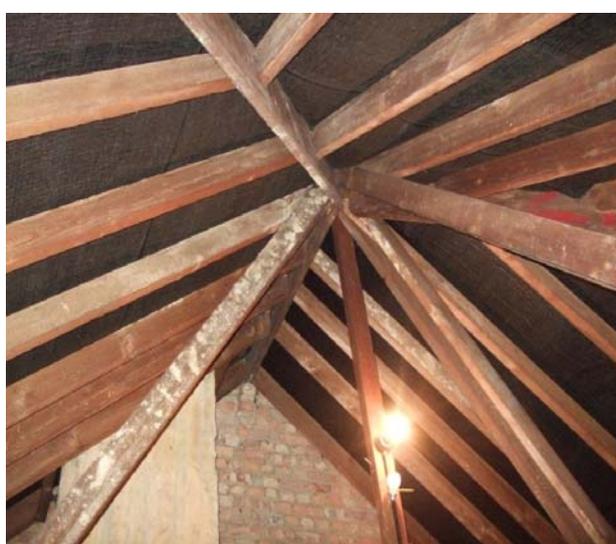
Photo ref: 15
Floor: roof structure
Room:
Position:
Product: No visible suspects

Material Assessment: N/A
Risk Category:

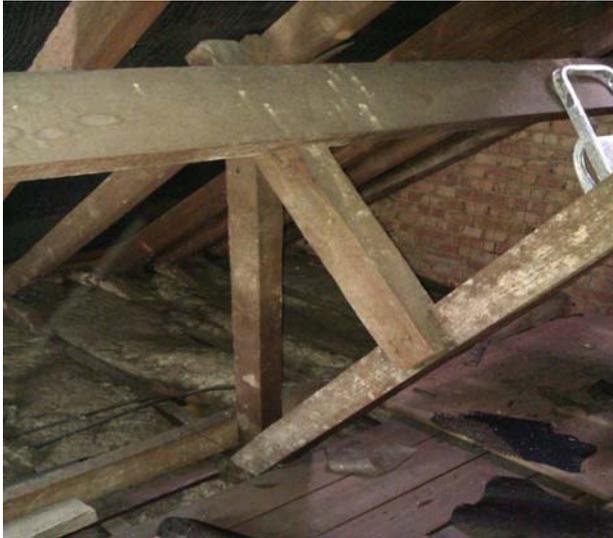
Photo ref: 16
Floor: roof structure
Room:
Position:
Product: No visible suspects

Material Assessment: N/A
Risk Category: 0

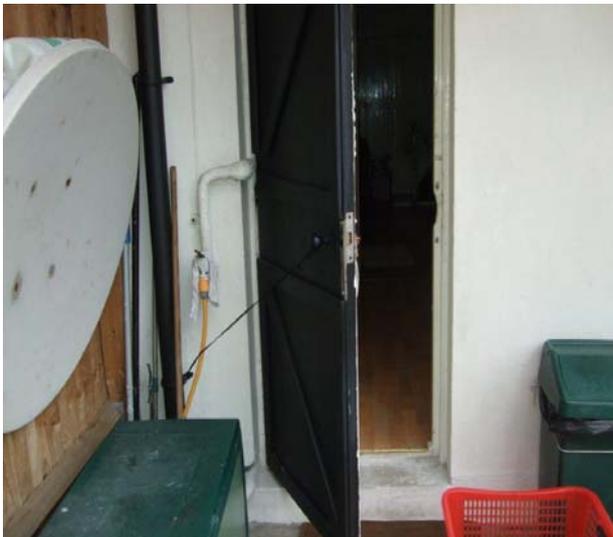
Photo ref: 17
Floor: Ground
Room: Rear door area
Position:
Product: No visible suspects

Material Assessment: N/A
Risk Category:

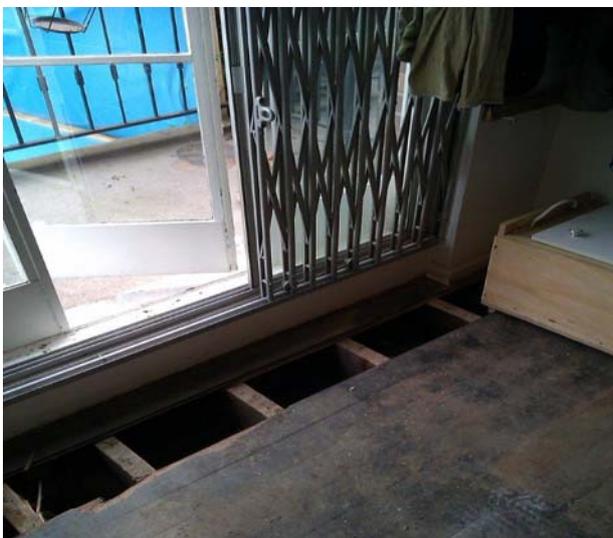
Photo ref: 18
Floor: 1st
Room: dining room
Position: Void under floor
Product: No visible suspects

Material Assessment: N/A
Risk Category:
